LIFT CONDITION SURVEY REPORT

Site: Centenary Mill Court
New Hall Lane
Preston
PR1 5JQ

Date of Survey: 1st July 2025

ILECS Ref: CM250473

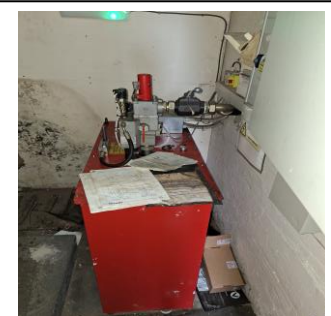
- 4.3.1 The lifts were not in service at time of survey, so we were unable to check the ride quality.
- 4.3.2 Parts are still readily available for this type of pump unit.
- 4.3.3 There were no reported issues with the pump unit listed on the log cards for either of the lifts.

Hydraulic pump unit

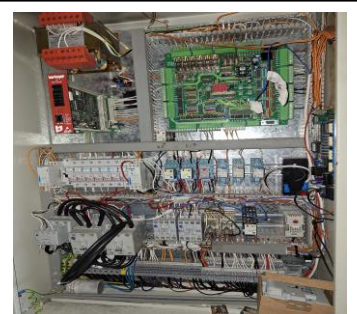
- 4.4.1 There are various health and safety issues/ recommendations within the lift machine rooms, which are listed at the rear of this report.
- 4.4.2 The machine room lighting is poor and should be upgraded to provide the correct 200 lux level.
- 4.4.3 The controllers are past their life expectancy and some of the breakdowns on the log cards are due to failed parts within the control panels. These parts are not readily available and take time to source.

Controller

- 4.4.4 The machine rooms should be kept clean and decluttered by the service provider on each maintenance visit.

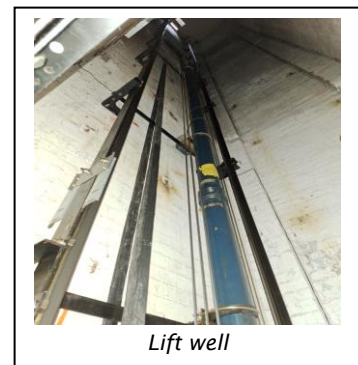
DETAIL/COMMENT	CONDITION/COMPLIANCE
Construction	<i>Block and brick</i>	<i>Satisfactory</i>
Cleanliness	<i>Dusty, dirty and grimy</i>	<i>Improve</i>
Guides – Car/Counterweight	<i>Tee section</i>	<i>Satisfactory</i>
Well Lighting/Switching	<i>Not working at time of survey</i>	<i>Improve</i>
Trailing Cables	<i>Flatform PVC</i>	<i>Satisfactory</i>

- 4.5.1 There are various health and safety issues/ recommendations within the lift well, which are listed at the rear of this report.
- 4.5.2 The car tops should be cleaned and a new compliant handrail with kick plates installed where gaps exceed 300mm.
- 4.5.3 The lift wells should be decorated throughout with white paint to improve the lighting lux levels and reduce dust.

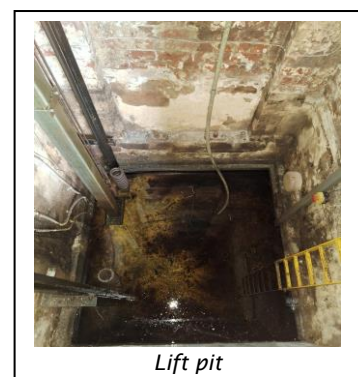
- 4.6.1 There are various health and safety issues/ recommendations within the lift pit, which are listed at the rear of this report.
- 4.6.2 Both lift pits have water ingress. We recommend the lift pits be cleaned, and all water and oil removed. The water ingress should be investigated and where necessary, the lift pits should be tanked to prevent further ingress.

- 4.6.3 All lift equipment within the lift pit areas should be examined for water damage by the lift service provider once the pits have been cleaned.

- k) Investigate the reasons for the water ingress in the lift pits
- l) A thorough service of the lifts including testing of all lift safety features before putting the lifts back into service

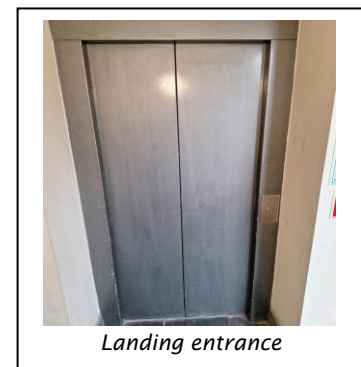
- 4.7.1 There are currently no landing position indicators on any floors. The requirement is to have one on the main landing entrance as a minimum to comply with EN81-70; however, we recommend that a landing position indicator be installed at all floors.

- 4.7.2 The landing buttons do not comply with Part M of the building regulations due to being within 500mm of an obstruction.

- 4.7.3 The power operated automatic centre opening doors have wear commensurate with age and use.

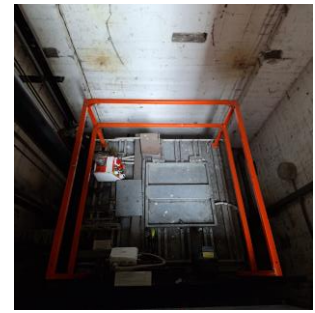
Lift car top

- 4.8.1 The lift car interiors and car doors were inaccessible at the time of survey due to the lifts being out of service.
- 4.8.2 To allow safe access and egress to the car top, the car top controls should be moved to the front of the lift cars; this allows engineers to safely test the controls before accessing the lift car top.
